MARINE SURVEY BUREAU

REPORT OF LIMITED SURVEY

(Hull Bottom & Structure)

S/Y “PIXELION”

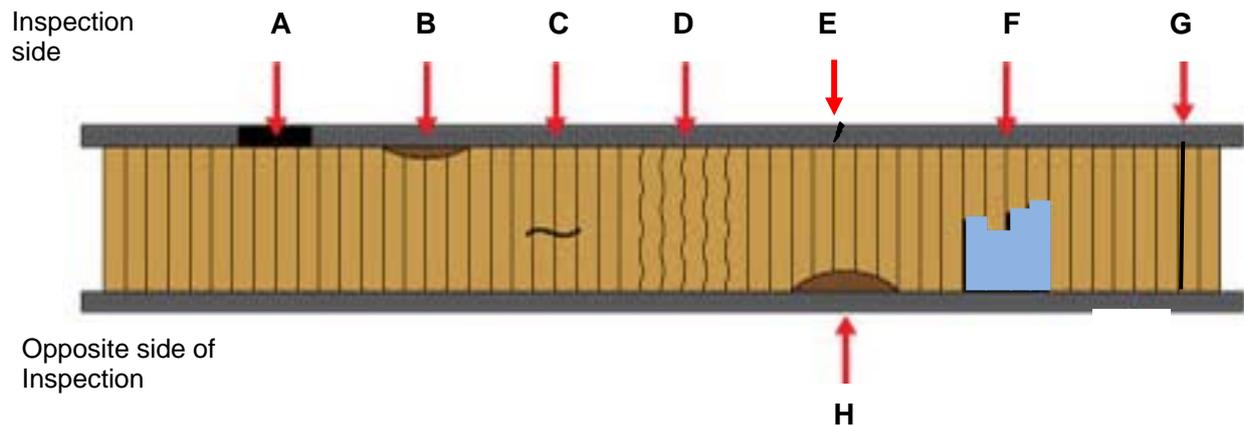
- Defect A: Delamination between plies of outer CFRP skin.
- Defect B: Disbonding between the outer skin and the core.
- Defect C: Cracked core parallel to the inspection surface.
- Defect D: Crushed core.
- Defect E: Linear breakages transversal to the laminate.
- Defect F: Fluid ingress in honeycomb core.
- Defect G: Core splice disbonds.
- Defect H: Debonding between inner skin and core.

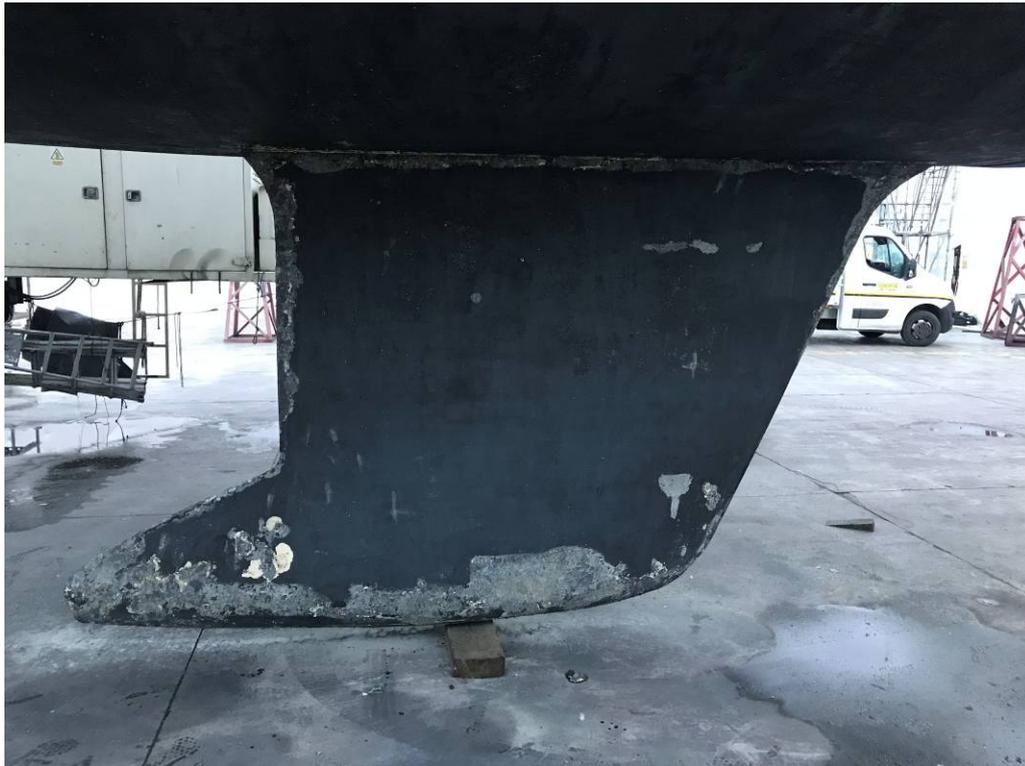
Only coatings to the lead keel were in unsatisfactory condition with paint scheme missing in large sections. ²

The L-shaped lead keel features integral stainless steel keel bolts. The keel appendix as a whole was seen in satisfactory order and showed no evidence of having taken grounds; however, the flexible compound at the joint to the hull would benefit from renewal. ³

Overview of keel

-
- ¹ Antifouling requires renewal prior to the next season. **(B)**
 - ² Coatings of the lead were seen in unsatisfactory condition. It is recommended to remove the current paint scheme and start with a new primer base coat. **(B)**

- ³ It is recommended to renew, at the next extended haul out, the external bead of flexible compound of the hull-to-deck join. **(C)**
 - ⁴ The finish of the bow thrusters tunnel installation is unsatisfactory. It is recommended to remove all loose filler, re-fair the area, over-laminate, and finish with primer and antifouling. **(C)**

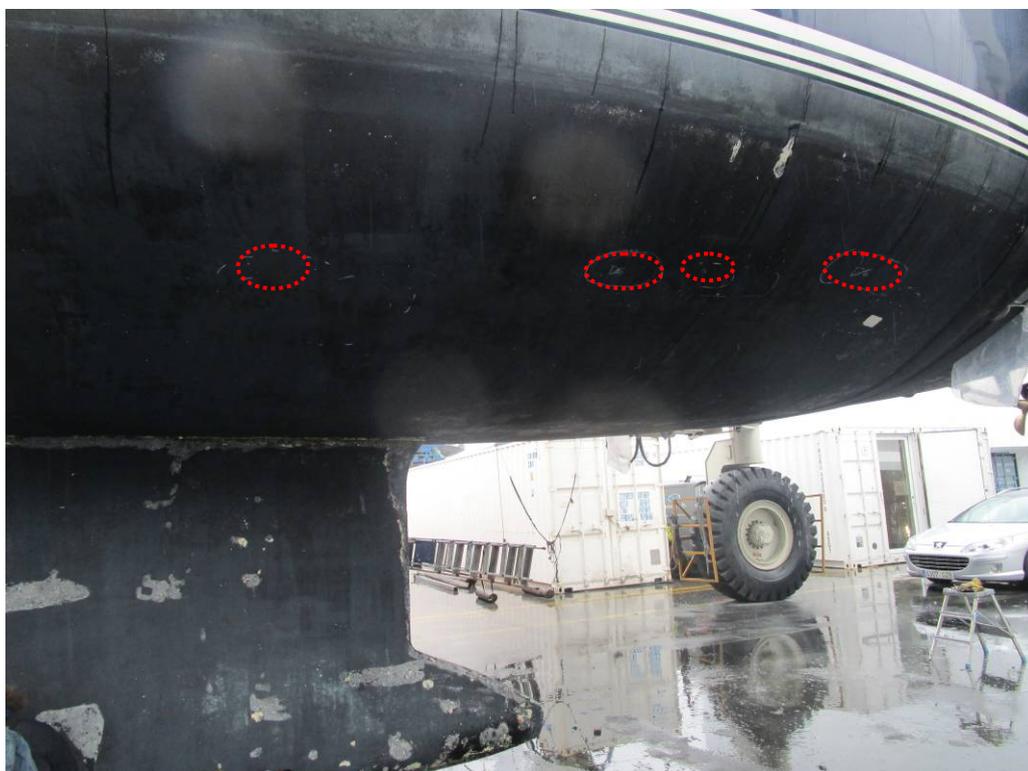
The entire hull was both acoustically sounded and inspected using non-destructive means. The former identified a number of locations with possible defects to the bond line between outer skin and core with also Infrared Thermography indicating that former propping positions have partly detached outer skins from the core. Those areas are all at the turn of the bilge, four on the port side and two to starboard. Although at this point not deemed of structural concern, it is best to investigate the issue further and rectify accordingly. ⁵

Indications of core disbond on port side

- ⁵ Both acoustic response and Infrared Thermography indicated that amidships, along the turn of the bilge, are some areas affected by core to outer-skin de-bond. The anomalies, four on the port side and two to starboard, are believed to have been caused by inappropriate blocking of the vessel and measure approx 200mm in diameter. Although at this point not deemed of structural concern it is best to investigate the issue further and rectify accordingly. **(B)**

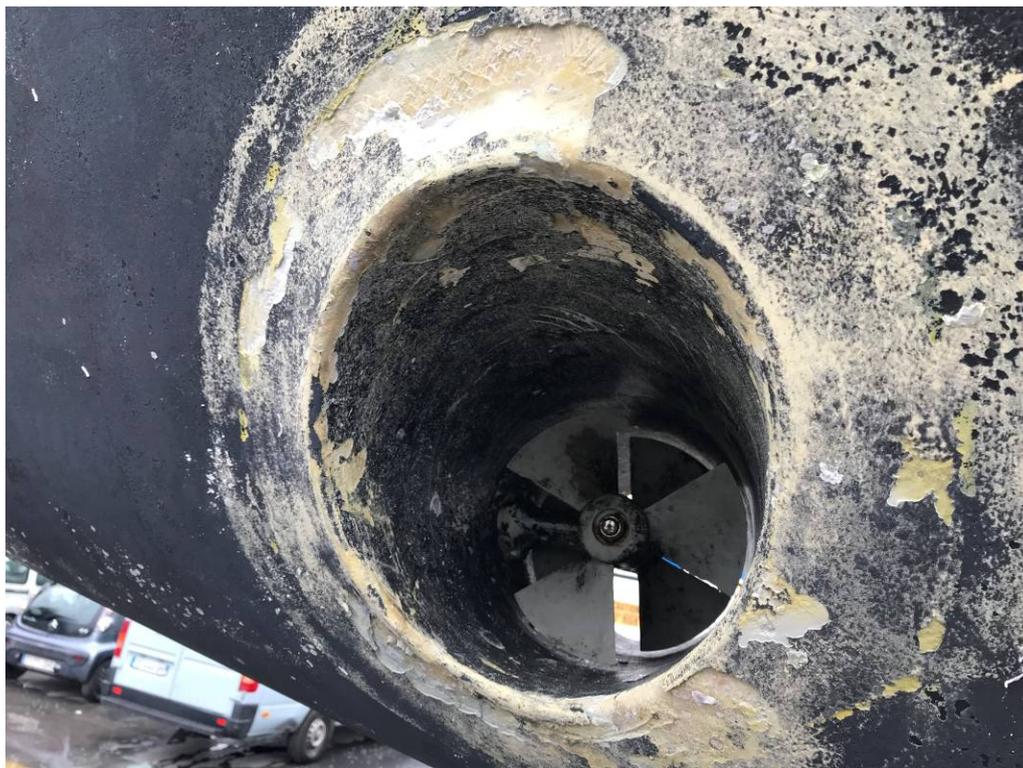
The bow-thruster tunnel has been retrofitted and would benefit from some attention to the fairing around its perimeter. ⁴

Bow-thruster with fairing peeling off around tunnel installation

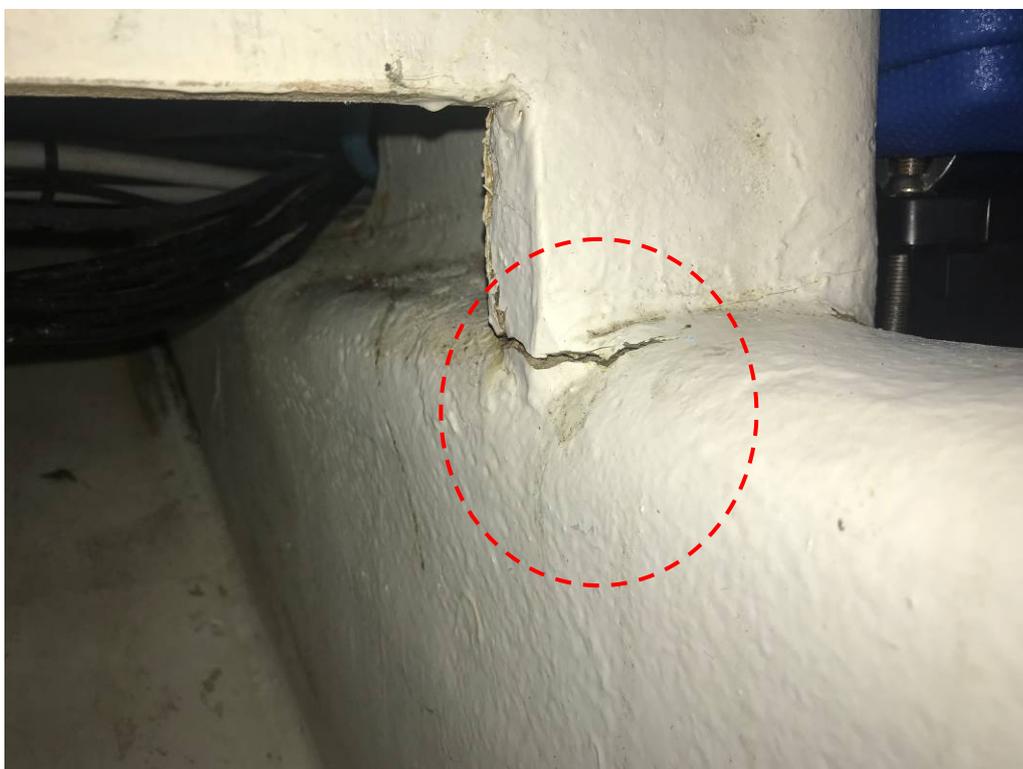
However, the anchoring of the floor structure at the base of the starboard forward hanging locker, was noted damaged. ⁷

Damaged anchoring of secondary structure onto primary reinforcements

- ⁷ The anchoring of the floor structure at the base of the starboard forward hanging locker was noted damaged. Grind open and re-laminate the tabbing. **(B)**

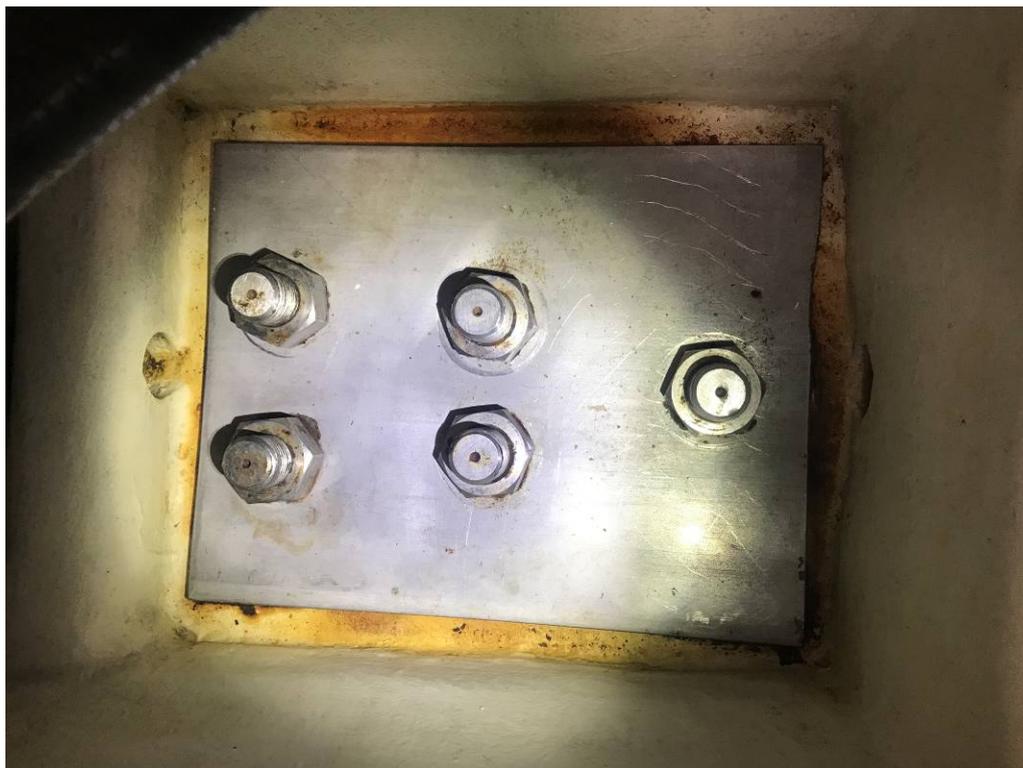
- The keelbolts are all fitted with a single nut only. No locking nut or other means of securing was noted. ⁸
- Large stainless steel backing plates link the bolts between frames. Although a good practise, they were not bedded down with only corners touching and a void between the plates and the hull. ⁹

Keelbolts with large backing plate; note absence of locking nuts

- ⁸ The keel-bolts should be secured by either adding a second 'locking' nut or other means to lock the nut in place. **(B)**
 - ⁹ Large stainless steel backing plates link the bolts between frames. Although a good practise, they were not bedded down with only corners touching and a void between the plates and the hull. It is recommended to lift plates and fill the space beneath with a dedicated chocking or grouting material (such as Chockfast) prior to re-tightening according to manufacturers specifications. **(B)**

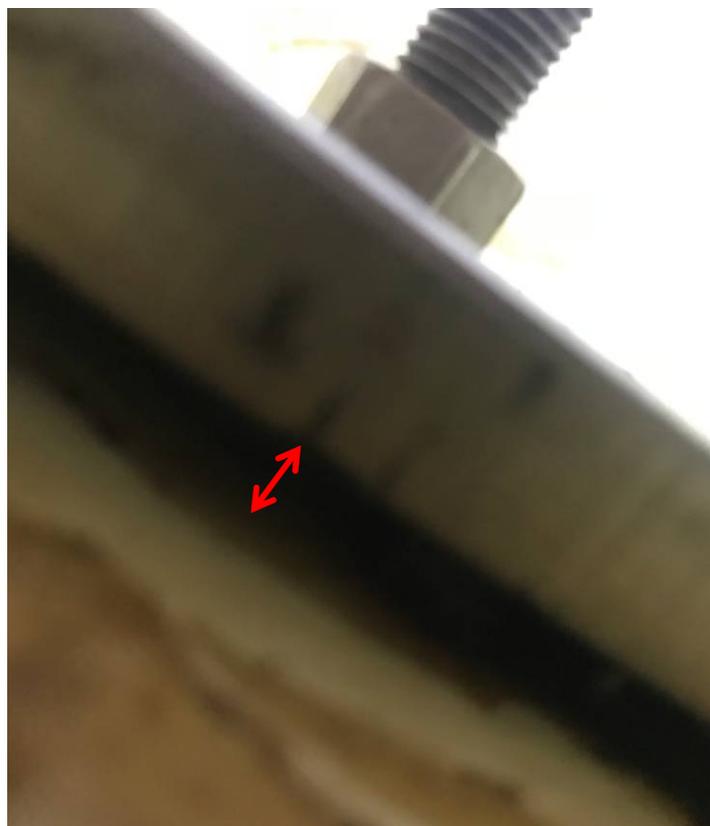
Gap beneath the backing plate

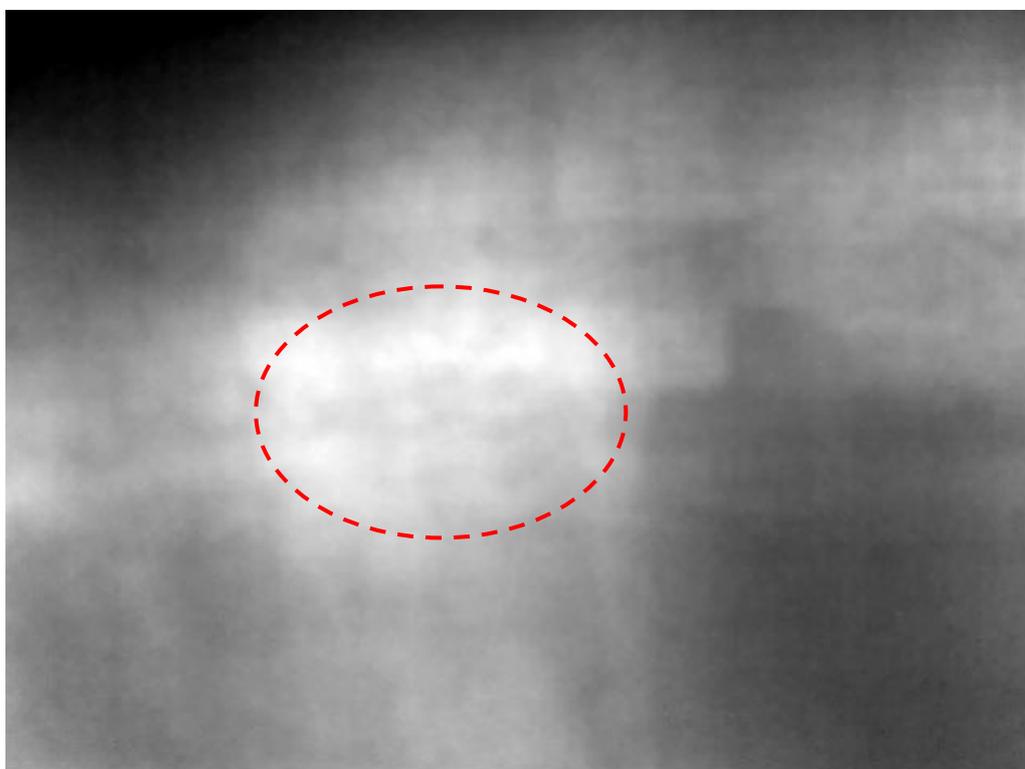
Greyscale thermogram of core disbond indication (port side)

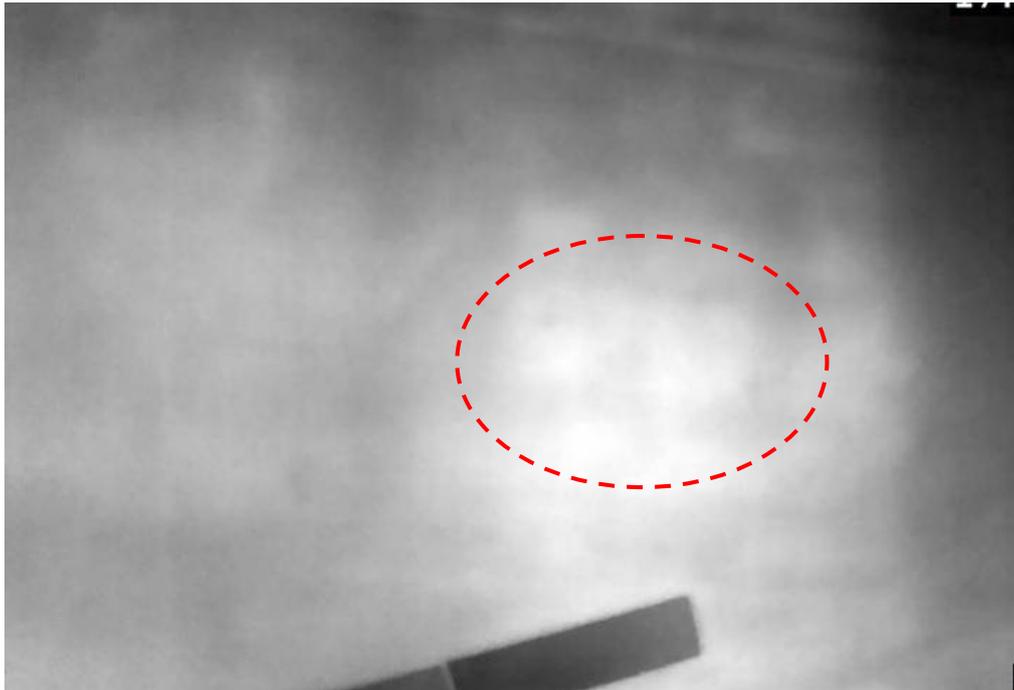
Greyscale thermogram of core disbond indication (starboard side

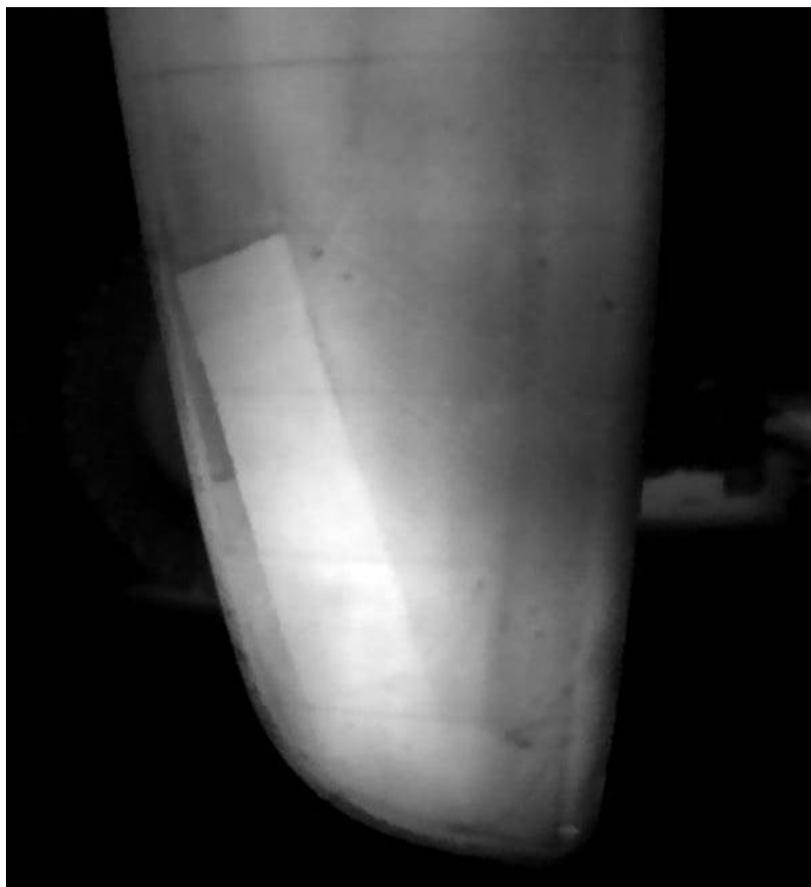
Infrared Thermography also depicted a previous repair at the bottom of the rudder.

Greyscale thermogram of rudder tip with repair clearly visible
